PRELIMINARY REPORT ON THE RESULTS OF THE  
EXCAVATION, MADE UNDER THE AUSPICES OF  
THE TURKISH HISTORICAL SOCIETY, IN THE  
CACA BEY MADRASA OF KIRŞEHİR, TURKEY.

Dr. AYDIN SAYILI,

Dr. WALTER RUBEN

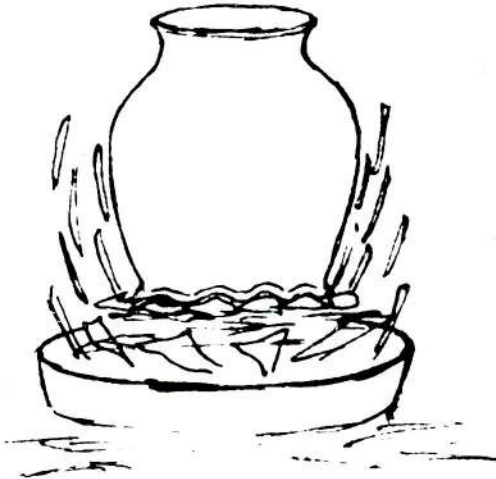
Res. 7 -- S. 679 -- 80'e bakınız.  
Fig. 7 -- See p. 690.

To the west of the well and within the excavated area a bell-shaped jar was found. Both its top and bottom were left open. The top was about 85 cm. below the platform, and the height of the jar was 90 cm. (figs. 7, 12). The edges of the bottom were decorated with a pattern of waves in relief. This jar was fixed firmly to a foundation constructed with pieces of stone and a mortar made of powdered brick (*khoraşân*), and its sides were supported and propped with the help of large pieces of pottery. The jar was found to be full of earth containing a few fragments of plain and glazed pottery as well as some bones and egg shells. The bones were mostly rib bones. Ashes, charcoal, and burnt pottery were found to be very abundant in the earth surrounding the jar. The jar itself, as well as the earth within it, was free from traces of fire. About 30 cm. below the bottom of this jar, a section, in the form of a ring, of another jar was found. This was larger in diameter and the height of this cylindrical ring was about 20 cm. (figs. 7, 13). Below this, no traces of burnt material existed. Inside the well too, burnt wood was occasionally encountered.

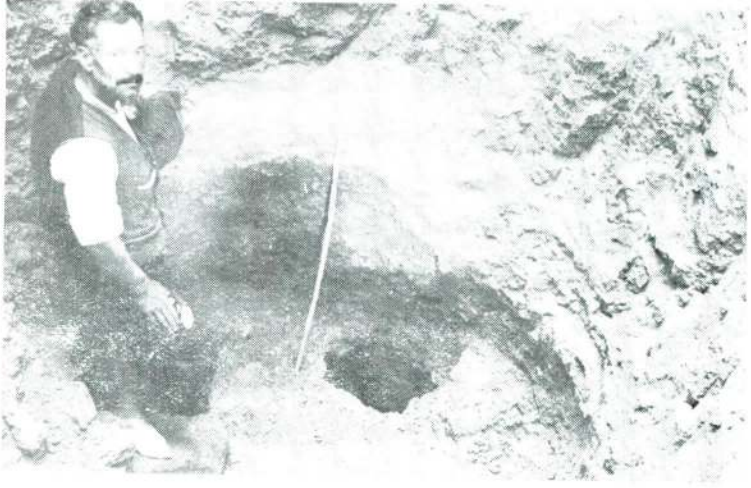
Res. 10 — Kuyunun ilk sarıh izi.  
Fig. 10 — The first clear sign showing the existence of the well.

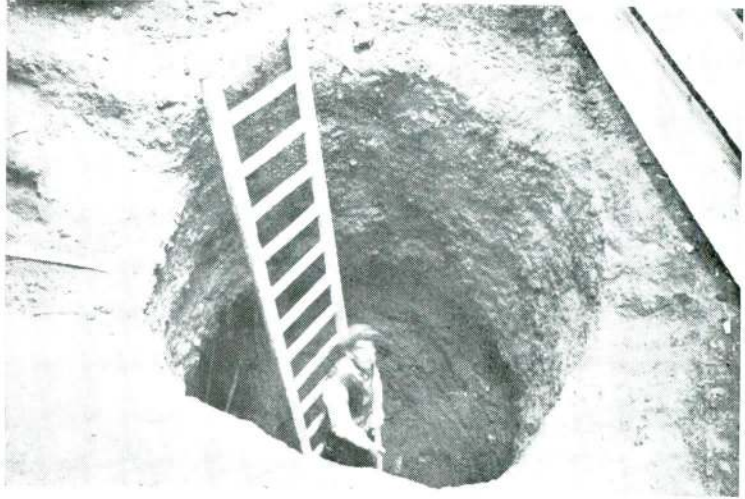
Res. 11 — Daha su çıkmadan kuyudan bir görünüş.  
Fig. 11 — A view of the well before the level of water was reached.

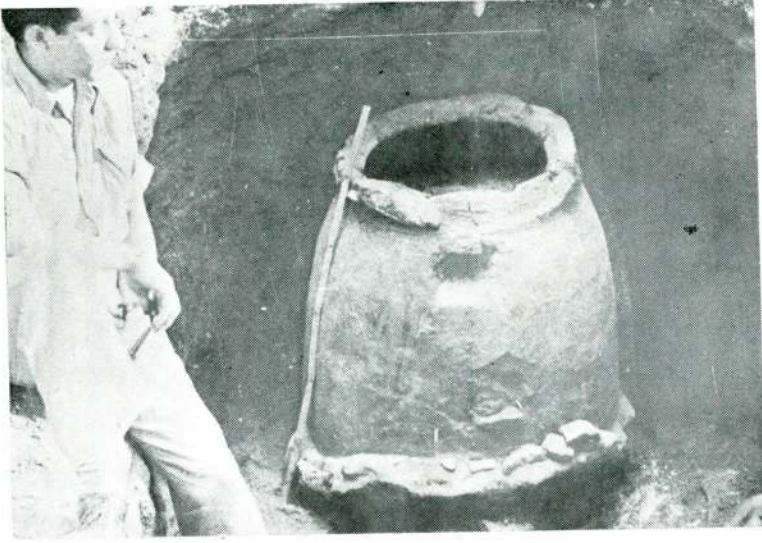
Res. 12 — Çan şeklindeki küp.  
Fig. 12 — The bell-shaped jar.

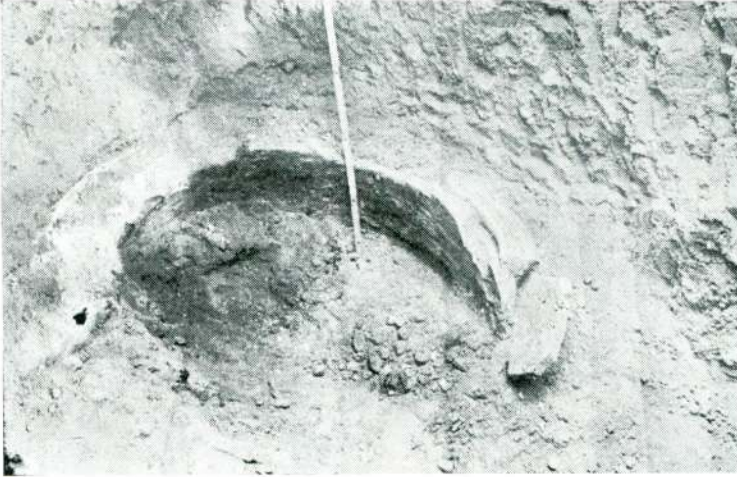
Res. 13 — Çember şeklindeki küp gövdesi parçasının yeri.  
Fig. 13 — The place where a section of a jar in the form of a  
ring was found.
